**Flood Control Project Maintenance
Levee Inspections****LMA District Cover Sheet
Spring 2014 Levee Inspection Results****Sutter Maintenance Yard Maintenance Area 0001**

Spring 2014 Levee Inspection Results

Sutter Maintenance Yard Maintenance Area 0001

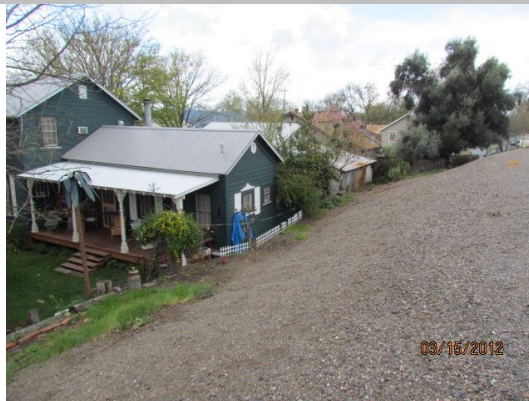
Photo 1 of 1 : rduffey_s_20140304_312.jpg

View of the building along the L/S toe.

LM Start	0.69	Rating **	U	Issue No.	7
LM End	0.71	Issue Type +	En	Location *	LS
Category	Earthen Levee			GPS Latitude/Longitude	
				Start	End
Item	Encroachments			39.216533 °	39.216680 °
				-122.012512 °	-122.012907 °
DWR ID	DWR_MA0001_01_s _ 2012_7				
Action/Comments					
Building

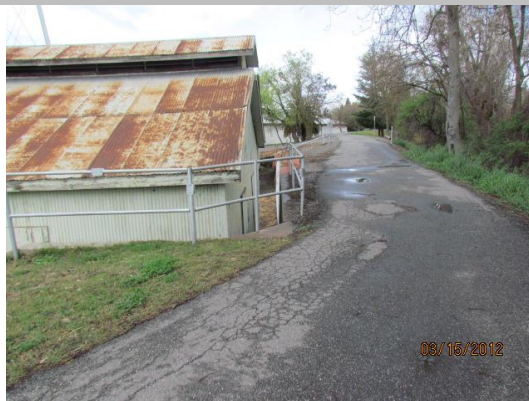
Photo 1 of 1 : rduffey_s_20140304_316.jpg

View of the buildings along the L/S toe.

LM Start	0.80	Rating **	U	Issue No.	8
LM End	0.95	Issue Type +	En	Location *	LS
Category	Earthen Levee			GPS Latitude/Longitude	
				Start	End
Item	Encroachments			39.217282 °	39.218215 °
				-122.014290 °	-122.016538 °
DWR ID	DWR_MA0001_01_s _ 2012_8				
Action/Comments					
Building

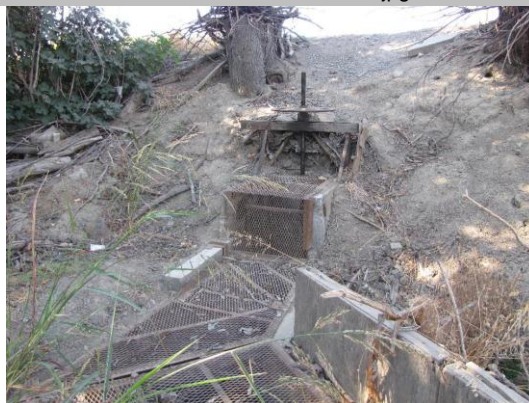
Photo 1 of 1 : UCIP_4800.jpg

LM Start	1.20	Rating **	M	Issue No.	9
LM End	1.20	Issue Type +	En	Location *	LS
Category	Supplemental			GPS Latitude/Longitude	
				Start	End
Item	DWR UCIP Field Study			39.221685 °	39.221685 °
				-122.015720 °	-122.015720 °
DWR ID	DWR_MA0001_01_s_2014_9				
Action/Comments					
Inspector Comments: FS_ID:25770					
EP_NO: 9481					
Repair Type:					
Crossing Status:					
UCIP Comments: Need pressure test/video inspection to determine integrity of pipe wall. WS-woody debris scattered along slope & bank. Erosion on bank near ditch. LS-discharge pipe heavily corroded & CMP section missing. This crossing was listed in the USACE Periodic Inspections as ID# USACE_CESPK_MA1C_2010_p_0097 for debris & encroachment within 15 feet/18/2013 LS outlet was underwater and could not be inspected but nothing looks to have been changed 12/17/2013 Same as last inspection.					
FIELD_STRUCT_DESC: 36-inch corrugated metal pipe (CMP) through the levee, slide gate on the waterward slope. (ABO No. 9481-1974, Roberts Ditch Irrigation Company) Crossing penetrates the levee at an angle. Other appurtenances located at this crossing include slant pump, concrete distribution box and shed structure located 100 feet northeast from levee crossing. Flow is carried from concrete distribution box to slide gate via concrete lined ditch. This entry matches the Drainage and Irrigation Structure referenced in O&M manual (Station 63+53).

Slide gate located on WS slope.

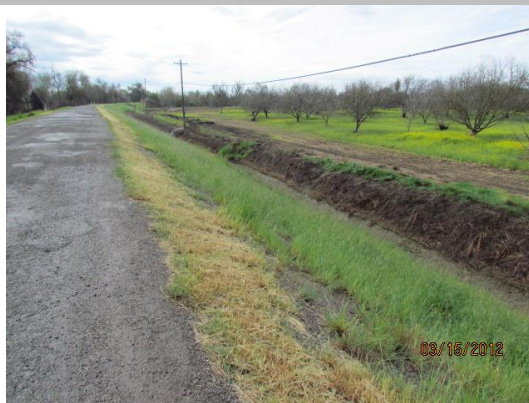
Photo 1 of 1 : rduffey_s_20140304_315.jpg

LM Start	1.23	Rating **	U	Issue No.	6
LM End	1.37	Issue Type +	En	Location *	LS
Category	Earthen Levee			GPS Latitude/Longitude	
				Start	End
Item	Encroachments			39.222119 °	39.224063 °
				-122.015747 °	-122.016080 °
DWR ID	DWR_MA0001_01_s_2012_6				
Action/Comments					
Ditch

View of ag. ditch along the L/S toe.

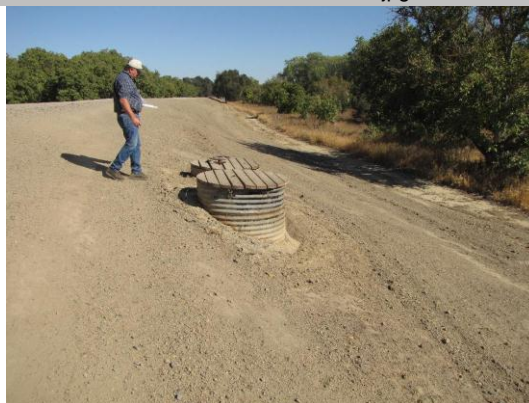
Photo 1 of 1 : UCIP_4802.jpg

LM Start	1.96	Rating **	M	Issue No.	10
LM End	1.96	Issue Type +	En	Location *	LS
Category	Supplemental			GPS Latitude/Longitude	
				Start	End
Item	DWR UCIP Field Study			39.231866 °	39.231866 °
				-122.015442 °	-122.015442 °
DWR ID	DWR_MA0001_01_s_2014_10				
Action/Comments					
Inspector Comments: FS_ID:25772					
EP_NO: 9487					
Repair Type:					
Crossing Status:					
UCIP Comments: Remove dirt and debris in riser. Outlet deformed and blocked over 50%. Debris-round concrete section on landward side. This crossing was listed in the USACE Periodic Inspections as ID# USACE_CESPK_MA1C_2010_p_0116 for crossing outlet deformed and clogged with dirt/18/2013 WS pipe end has been reformed but is still clogged about 50% by sediment 12/17/2013 Same as last inspection.					
FIELD_STRUCT_DESC: 1 of 2: 36-inch corrugated metal pipe (CMP) through the levee. Slide gates in CMP riser on the waterward slope. (ABO No. 9487-1974, Jimeno Rancho) This entry matches the Drainage and Irrigation Structure referenced in O&M manual (Station 103+18).

CMP riser located on waterward slope.

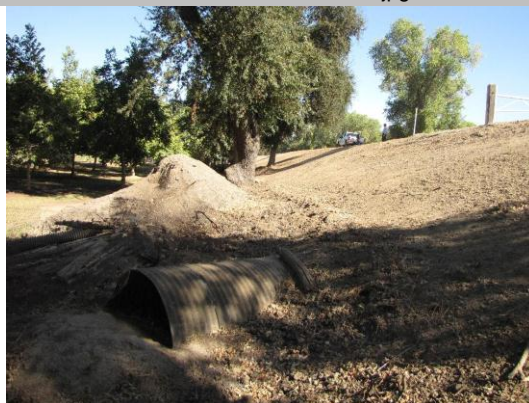
Photo 1 of 1 : UCIP_4824.jpg

LM Start	2.28	Rating **	M	Issue No.	17
LM End	2.28	Issue Type +	En	Location *	LS
Category	Supplemental			GPS Latitude/Longitude	
				Start	End
Item	DWR UCIP Field Study			39.235993 °	39.235993 °
				-122.012970 °	-122.012970 °
DWR ID	DWR_MA0001_01_s_2014_17				
Action/Comments					
Inspector Comments: FS_ID:25774					
EP_NO: 9472					
Repair Type:					
Crossing Status:					
UCIP Comments: Remove debris from riser. Landward inlet is blocked by over 50%. This crossing was listed in the USACE Periodic Inspections as ID# USACE_CESPK_MA1C_2010_p_0128 for sediment build up at inlet (landward side) and debris inside riser 7/18/2013					
Same as last inspection 12/17/2013 Same as last inspection.					
FIELD_STRUCT_DESC: 54-inch corrugated metal drain pipe through the levee. Slide gate in CMP riser on the waterward slope. 48-inch corrugated metal pipe at landward slope. This crossing crosses the levee at an angle. (ABO No. 9472-1974, Ballard) This entry matches the Drainage and Irrigation Structure referenced in O&M manual (Station 120+00) dated 1955.

Inlet located on landward side.

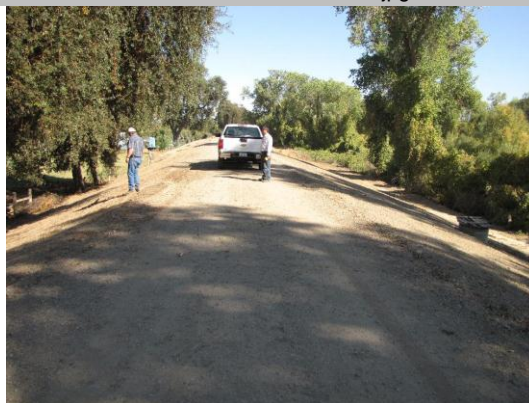
Photo 1 of 1 : UCIP_4828.jpg

LM Start	2.30	Rating **	M	Issue No.	30
LM End	2.30	Issue Type +	En	Location *	LS
Category	Supplemental			GPS Latitude/Longitude	
				Start	End
Item	DWR UCIP Field Study			39.236178 °	39.236178 °
				-122.012812 °	-122.012812 °
DWR ID	DWR_MA0001_01_s_2014_30				
Action/Comments					
Inspector Comments: FS_ID:25775					
EP_NO: 9467					
Repair Type:					
Crossing Status:					
UCIP Comments: Only riser visible. Debris and sediment blocking gate.					
Gate inside riser is buried and non-functional. If crossing is abandoned,					
owner needs to properly abandon. This crossing was listed in the					
USACE Periodic Inspections as ID#					
USACE_CESPK_MA1C_2010_p_0132 no culvert through the levee is					
visible her7/18/2013 Same as last inspection12/17/2013 Same					
as last inspection.					
FIELD_STRUCT_DESC: 24-inch corrugated metal drain pipe through					
levee. Slide gate in CMP riser on the waterward slope. (ABO No. 9467-

Overview of levee crown looking upstream at crossing.

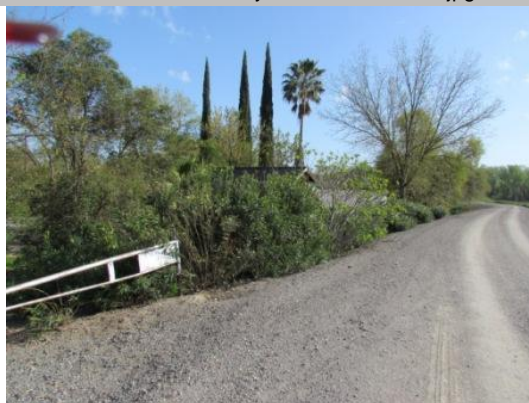
Photo 1 of 1 : rduffey_s_20140304_324.jpg

LM Start	2.58	Rating **	U	Issue No.	20
LM End	2.60	Issue Type +	En	Location *	LS
Category	Earthen Levee			GPS Latitude/Longitude	
				Start	End
Item	Encroachments			39.239750 °	39.239955 °
				-122.010390 °	-122.010090 °
DWR ID	DWR_MA0001_01_s_2012_20				
Action/Comments					
Building

View of the house next to the levee.

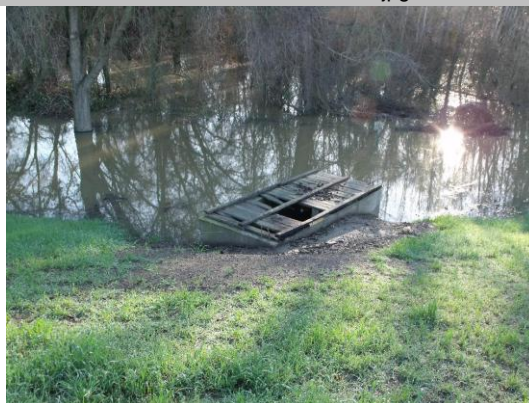
Photo 1 of 1 : UCIP_4838.jpg

Action/Comments					
Inspector Comments: FS_ID:25776					
EP_NO: 9474					
Repair Type:					
Crossing Status:					
UCIP Comments: During high water flow goes through levee. Missing positive closure device on waterward side. This structure appears abandoned-slide gates have been removed. Crossing needs to be properly abandoned. This crossing was listed in the USACE Periodic Inspection as ID# USACE_CESPK_MA1C_2010_p_0169 for concrete box partially filled with dirt/18/2013 Same as last inspection12/17/2013 Same as last inspection.					
FIELD_STRUCT_DESC: 1 of 2: 60-inch concrete pipe through the levee. Slide gates in concrete well at the waterward toe. (ABO No. 9474-1974, George R. Zumwalt) This entry matches the Drainage and Irrigation Structure referenced in O&M manual (Station 150+06). O&M description is for 2-5 foot by 5 foot concrete culverts 2-slide gates hand operated. Culvert constructed with wing walls and gate well.

View of concrete distribution box located on waterward shoulder-photo taken Jan-2010 during high water.

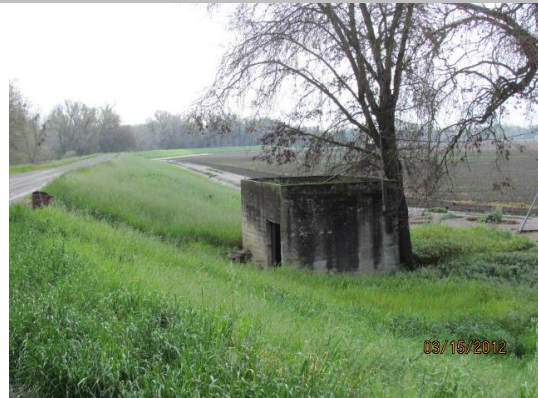
Photo 1 of 1 : rduffey_s_20140304_314.jpg

View of the ag. ditch & concrete building along the L/S toe.

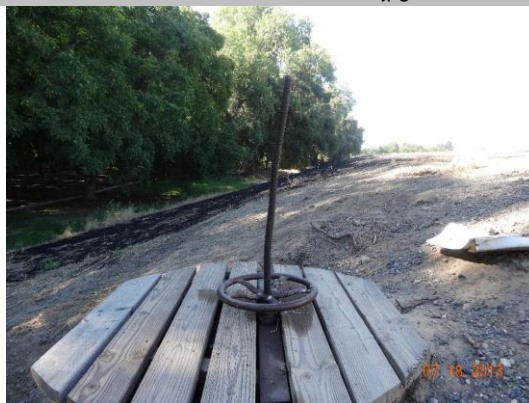
Photo 1 of 1 : UCIP_4858.jpg

LM Start	3.40	Rating **	M	Issue No.	33
LM End	3.40	Issue Type +	En	Location *	LS
Category	Supplemental			GPS Latitude/Longitude	
				Start	End
Item	DWR UCIP Field Study			39.250843 °	39.250843 °
				-122.007992 °	-122.007992 °
DWR ID	DWR_MA0001_01_s_2014_33				
Action/Comments					
Inspector Comments: FS_ID:25779					
EP_NO: 9490					
Repair Type:					
Crossing Status:					
UCIP Comments: LS pipe slightly deformed and sediment build up blocking about 30% of opening; need to check the condition of the slide gate-need photo. Metal marker down. This crossing was listed in the USACE Periodic Inspection as ID#					
USACE_CESPK_MA1C_2010_p_0187 for sediment build up at landward to 8/18/2013 WS slide gate looks to be in good condition but stem is slightly bent. Not sure if bend will hinder gates operation or not. LS inlet is still blocked by minor sediment build up 2/17/2013 Same as last inspection.					
FIELD_STRUCT_DESC: 36-inch drain pipe through the levee. Slide gate in CMP riser on the waterward slope. (Permit No. 9490-1955) This entry matches the Drainage and Irrigation structure referenced in O&M manual (Station 177+67). (USACE-1955)

Bent screw gate stem

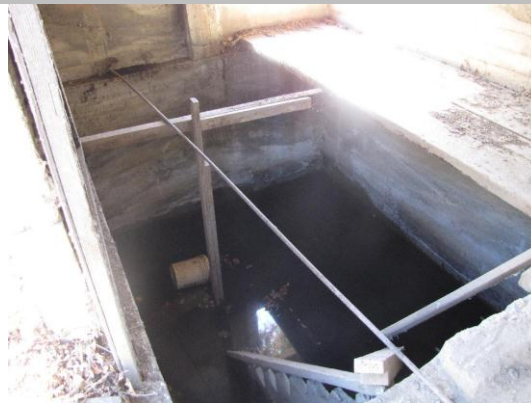
Photo 1 of 1 : UCIP_4862.jpg

LM Start	3.76	Rating **	M	Issue No.	34
LM End	3.76	Issue Type +	En	Location *	LS
Category	Supplemental			GPS Latitude/Longitude	
				Start	End
Item	DWR UCIP Field Study			39.255803 °	39.255803 °
				-122.009683 °	-122.009683 °
DWR ID	DWR_MA0001_01_s_2014_34				
Action/Comments					
Inspector Comments: FS_ID:25780					
EP_NO: 4213					
Repair Type:					
Crossing Status:					
UCIP Comments: Recommend adding door to LS concrete structure.					
Riser located on landward side is damaged. This crossing was listed in					
the USACE Periodic Inspection as ID#					
USACE_CESPK_MA1C_2010_p_0194 no issues logged 7/18/2013					
Same as last inspection 12/17/2013 Same as last inspection.					
FIELD_STRUCT_DESC: 24-inch pipe through the levee. Gate valve on					
waterward shoulder. 1-1/4 inch conduit through the levee. Siphon					
breaker on the landward shoulder. Concrete pump house. (Permit No.					
4213-1973, Scott Ranch)

View inside concrete distribution box located on landward side.

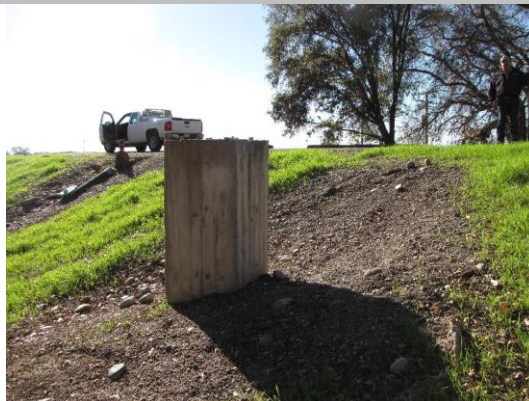
Photo 1 of 1 : UCIP_4867.jpg

LM Start	3.79	Rating **	M	Issue No.	36
LM End	3.79	Issue Type +	En	Location *	LS
Category	Supplemental			GPS Latitude/Longitude	
				Start	End
Item	DWR UCIP Field Study			39.256189 °	39.256189 °
				-122.009957 °	-122.009957 °
DWR ID	DWR_MA0001_01_s_2014_36				
Action/Comments					
Inspector Comments: FS_ID:25781					
EP_NO: 9490					
Repair Type:					
Crossing Status:					
UCIP Comments: Crossing needs to be properly abandoned. This crossing was listed in the USACE Periodic Inspection as ID#					
USACE_CESPK_MA1C_2010_p_0194-6 & 7 no issues					
logged 7/18/2013 Same as last inspection12/17/2013 Same as last inspection.					
FIELD_STRUCT_DESC: Abandoned 36-inch corrugated metal pipe (CMP) through levee. Concrete distribution box with pump system located on landward side. Slide gate on the waterward slope removed. (ABO No. 9490-1974, Charles T & Virginia W. Yerxa) This entry matches the Drainage and Irrigation Structure referenced in O&M manual (Station 197+19).

Abandoned concrete column located on waterward slope.

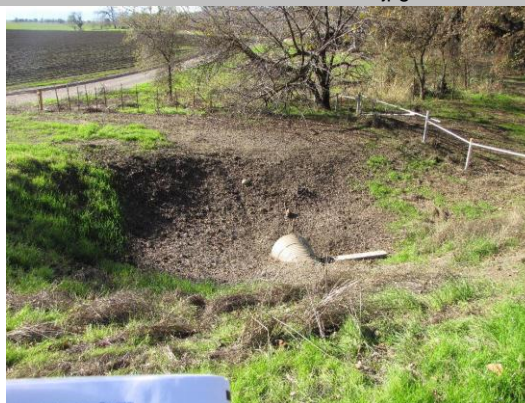
Photo 1 of 1 : UCIP_4870.jpg

UCIP Comments: Slide gate wheel handle missing. Clear debris from CMP riser. This crossing was listed in the USACE Periodic Inspection as ID# USACE_CESPK_MA1C_2010_p_0196 for access box contains backfilled (permanently shut) and outlet located on landside has sediment build up 7/18/2013 Same as last inspection 12/17/2013 Same as last inspection.

Landward side

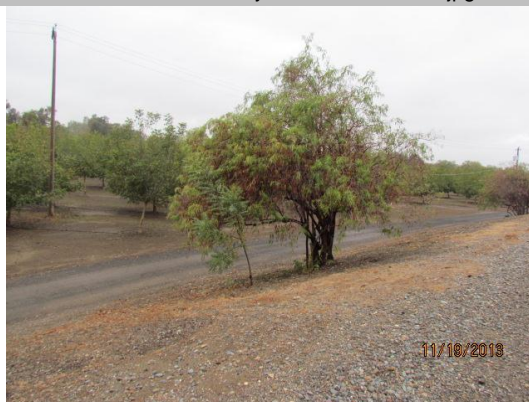
Photo 1 of 1 : rduffey_s_20140304_327.jpg

LM Start	3.96	Rating **	M	Issue No.	50
LM End	3.96	Issue Type +	Ma	Location *	LS
Category	Earthen Levee			GPS Latitude/Longitude	
				Start	End
Item	Vegetation			39.257125 °	39.257125 °
				-122.012648 °	-122.012648 °

View of the elderberry on the landside slope.

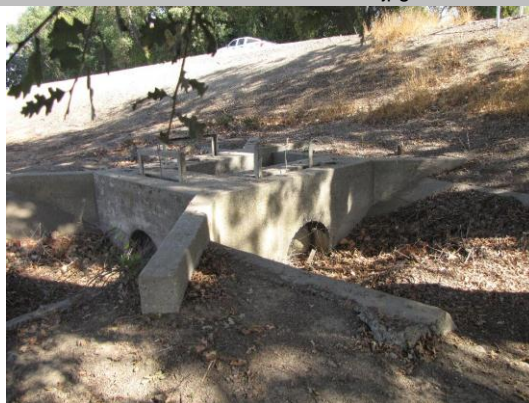
Photo 1 of 1 : UCIP_4884.jpg

Inspector Comments: FS_ID:25785
 EP_NO: N/A
 Repair Type:
 Crossing Status:
 UCIP Comments: WS-wheel to operate slide gate missing, walkway has been removed; burrow activity near structure; debris in concrete distribution box WS blocking gate. This crossing was listed in the USACE Periodic Inspection as ID# USACE_CESPK_MA1C_2010_p_0207 the wheel to operate sluice gate missing 1/18/2013 Wheel to operate slide gate has been replaced but gate is still blocked by debris 2/17/2013 Same as last inspection. FIELD_STRUCT_DESC: 24-inch pipe through the levee. Walkway to slide gate on waterward end. Walkway has been removed. Flap gate in concrete distribution box at the landward toe. (ABO - Wilcox)
 FS Date: 12/30/2013 12:27:39 PM

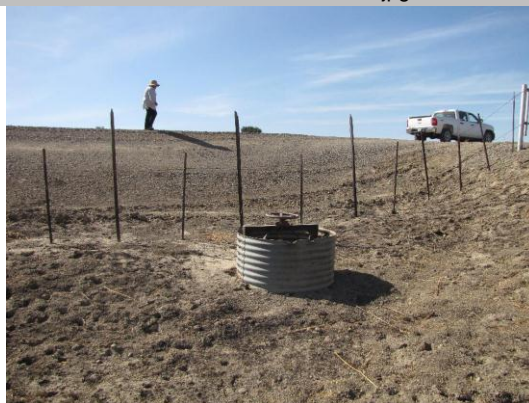
Photo 1 of 1 : UCIP_4890.jpg

LM Start	4.75	Rating **	M	Issue No.	40
LM End	4.75	Issue Type +	En	Location *	WS
Category	Supplemental			GPS Latitude/Longitude	
				Start	End
Item	DWR UCIP Field Study			39.266435 °	39.266435 °
				-122.010943 °	-122.010943 °
DWR ID	DWR_MA0001_01_s_2014_40				
Action/Comments					
Inspector Comments: FS_ID:25786					
EP_NO: 9475					
Repair Type:					
Crossing Status:					
UCIP Comments: Burrow activity; limited visibility of this crossing only on WS riser. This crossing was listed in the USACE Periodic Inspection as ID# USACE_CESPK_MA1C_2010_p_0207 the wheel to operate sluice gate missing. Issue addressed wheel to slide gate has been installed7/18/2013 Same as last inspection12/17/2013 Same as last inspection.					
FIELD_STRUCT_DESC: 30-inch corrugated metal pipe through the levee, 16.1 feet below the crown. Slide gate on the waterward end. (ABO No. 9475-1974, Mattie B. Zumwalt Co.) This entry matches the Drainage and Irrigation Structure referenced in O&M manual (Station 247+86).

Riser with slide gate located on waterward toe.

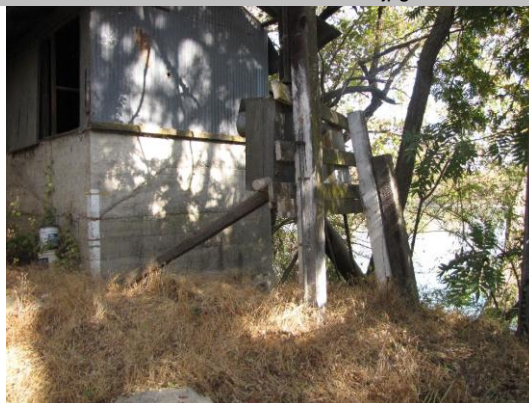
Photo 1 of 1 : UCIP_4902.jpg

Inspector Comments: FS_ID:25788
EP_NO: 9476
Repair Type:
Crossing Status:
UCIP Comments: blocked, no entry on WS. This crossing was listed in the USACE Periodic Inspection as ID# USACE_CESPK_MA1C_2010_p_0247 for u/s and d/s wing wall shows some cracking and tilting 7/18/2013 Same as last inspection 12/17/2013 Same as last inspection.
FIELD_STRUCT_DESC: 1 of 2: 36-inch corrugated metal pipe (15 feet long) and concrete box culvert through the levee. (ABO No. 9476-1974, Howard C. & Nadine M. Ohliger)
FS Date: 12/30/2013 12:33:33 PM

Pump structure located on berm edge.

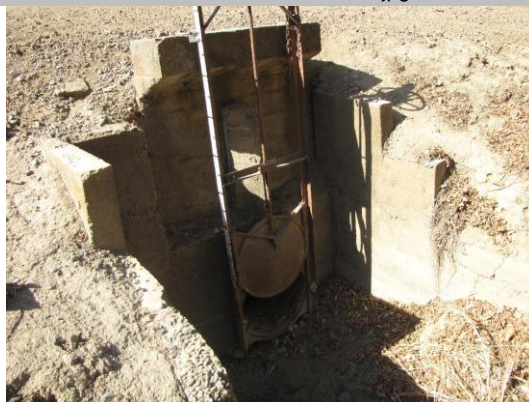
Photo 1 of 1 : UCIP_4903.jpg

Inspector Comments: FS_ID:25789
EP_NO: 9476
Repair Type:
Crossing Status:
UCIP Comments: blocked, no entry on WS. This crossing was listed in the USACE Periodic Inspection as ID# USACE_CESPK_MA1C_2010_p_0247 for u/s and d/s wing wall shows some cracking and tilting 7/18/2013 Same as last inspection 12/17/2013 Same as last inspection.
FIELD_STRUCT_DESC: 2 of 2: 36-inch corrugated metal pipe (15 feet long) and concrete box culvert through the levee. Slide gate located on waterward. (ABO No. 9476-1974, Howard C. & Nadine M. Ohliger)
FS Date: 12/30/2013 12:35:59 PM

Headwall and slide gate located on waterward side.

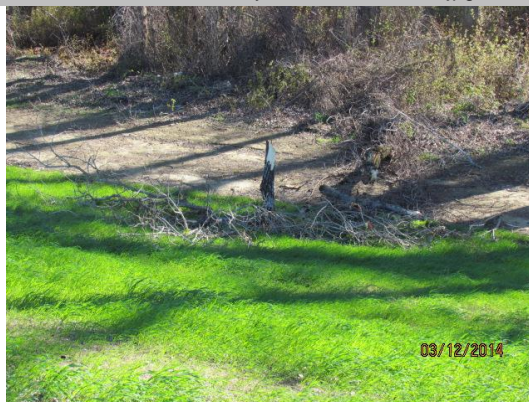
Photo 1 of 1 : rduffey_s_20140317_118.jpg

View of the downed tree on the waterside slope.

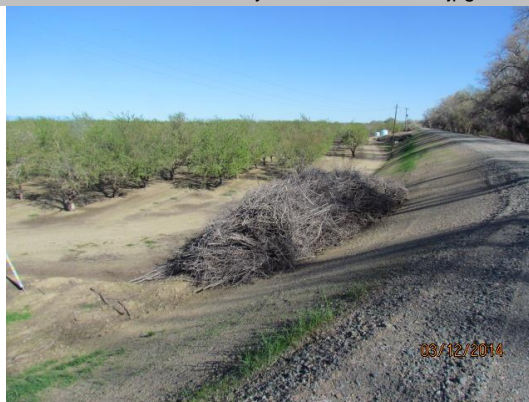
Photo 1 of 1 : rduffey_s_20140317_119.jpg

LM Start	6.24	Rating **	M	Issue No.	75
LM End	6.24	Issue Type +	En	Location *	LS
Category	Earthen Levee			GPS Latitude/Longitude	
				Start	End
Item	Encroachments			39.277656 °	39.277656 °
				-122.022936 °	-122.022936 °
DWR ID	DWR_MA0001_01_s _ 2014_75				
Action/Comments					
Prunings

View of the prunings along the landside slope.

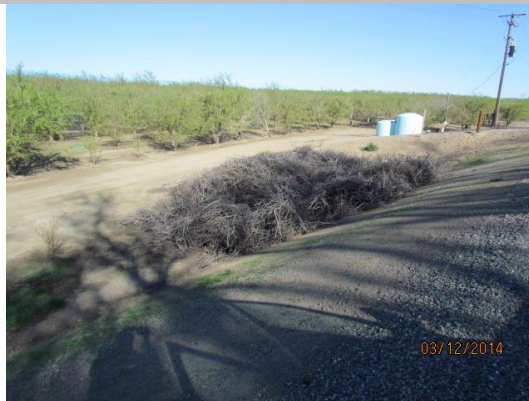
Photo 1 of 1 : rduffey_s_20140317_120.jpg

View of the prunings along the landside toe.

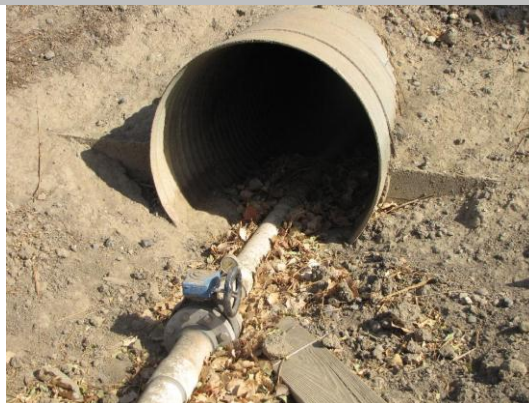
Photo 1 of 1 : UCIP_5247.jpg

5-inch pipe goes through 36-inch drainage pipe.

Inspector Comments: FS_ID:26383
 EP_NO: 4203
 Repair Type:
 Crossing Status:
 UCIP Comments: Unauthorized 5 inch PVC pipe running through 36 inch crossing. 5 inch PVC crossing prevents slide gate from closing during high water. Debris and sediment inside riser. This crossing was listed in the USACE Periodic Inspection as ID# USACE_CESPK_MA1C_2010_p_0258 for 5 inch PVC pipe running through culvert 7/18/2013 Same as last inspection 12/17/2013 Same as last inspection.
 FIELD_STRUCT_DESC: 36-inch pipe through the levee. Slide gate in CMP riser on the waterward slope. This entry matches the Drainage and Irrigation Structure referenced in O&M manual (Station 331+31).
 FS Date: 1/6/2014 8:21:26 AM

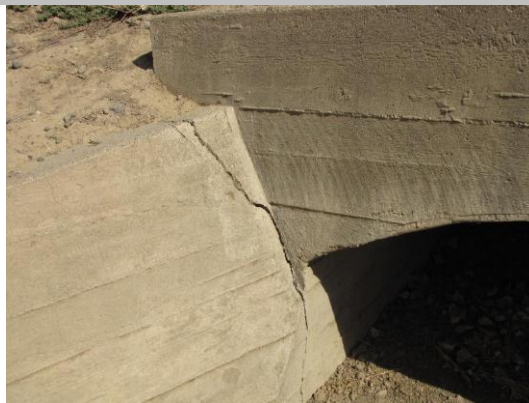
Photo 1 of 1 : UCIP_4912.jpg

Inspector Comments: FS_ID:25793
 EP_NO: N/A
 Repair Type:
 Crossing Status:
 UCIP Comments: Need to be properly abandoned concrete structure; plate covers concrete box; Concrete headwall damaged. This crossing was listed in the USACE Periodic Inspection as ID# USACE_CESPK_MA1C_2010_p_0262 for damage to concrete structure (vertical 2 inch wide cracks and spalling visible) 7/18/2013 Same as last inspection 12/17/2013 Same as last inspection.
 FIELD_STRUCT_DESC: Abandoned 72-inch corrugated metal drain (precast concrete) pipe through the levee, blocked on waterward end with 3-foot concrete plug installed in 1980. Slide gate in concrete well on the landward shoulder. Concrete headwall at both toes. This entry matches the Drainage and Irrigation Structure referenced in O&M manual (Station 339+74)
 FS Date: 12/30/2013 12:42:51 PM

Damage wingwall (upstream) - vertical crack.

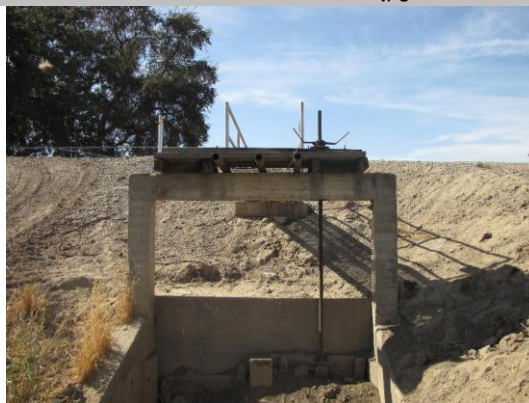
Photo 1 of 1 : UCIP_4918.jpg

LM Start	7.14	Rating **	M	Issue No.	48
LM End	7.14	Issue Type +	En	Location *	LS
Category	Supplemental			GPS Latitude/Longitude	
				Start	End
Item	DWR UCIP Field Study			39.290147 °	39.290147 °
				-122.021525 °	-122.021525 °
DWR ID	DWR_MA0001_01_s_2014_48				
Action/Comments					
Inspector Comments: FS_ID:25794					
EP_NO: 9482					
Repair Type:					
Crossing Status:					
UCIP Comments: Structure is buried and non-operational. This crossing was listed in the USACE Periodic Inspection as ID# USACE_CESPK_MA1C_2010_p_0288 for sluice gate closed and backfilled on WS and full of sediment with wingwall cracked on LS/18/2013 Same as last inspection12/17/2013 Same as last inspection.					
FIELD_STRUCT_DESC: 1 of 2: 36-inch concrete pipes through the levee. Wooden slide gates on waterward end. Concrete culvert through levee. Sliding metal gate noted in O&M manual. This entry could match the Drainage or Irrigation Structure referenced in the O&M manual (Station 370+90) (USACE-1955)(ABO No. 9482-1974, Elizabeth M. Farnsworth).

Only 1 slide gate remains, 2nd slide gate has been removed.

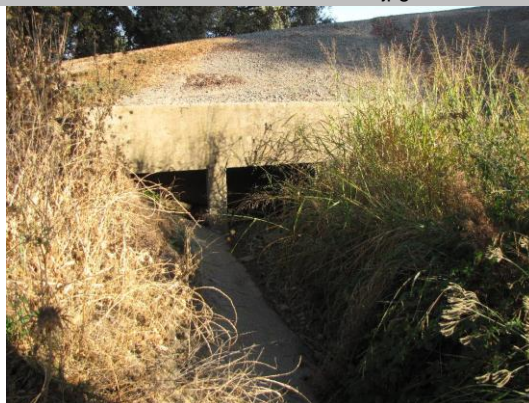
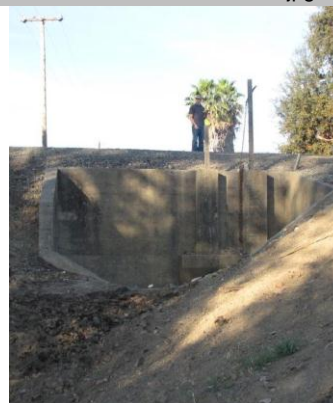
Action/Comments					
Inspector Comments: FS_ID:25796					
EP_NO: N/A					
Repair Type:					
Crossing Status:					
UCIP Comments: Sediment and debris on waterward and landward side.					
This crossing was listed in the USACE Periodic Inspection as ID#					
USACE_CESPK_MA1C_2010_p_0293 for wooden slide gate held open					
by a piece of rebar acting as a pin 7/18/2013 Same as last					
inspection 12/17/2013 Same as last inspection.					
FIELD_STRUCT_DESC: 5 foot by 6 foot concrete box culvert through					
the levee and access ramp. Two wooden slide gates on waterward end.					
Concrete v-ditch along landward toe. This entry matches the Drainage					
and Irrigation Structure referenced in O&M manual (Station 385+33.5).					
FS Date: 12/30/2013 12:59:59 PM

View of concrete headwall under access ramp with concrete v-ditch.

View of concrete structure on waterward side.

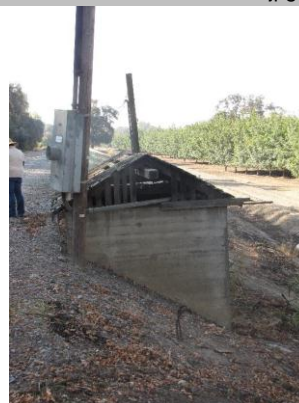
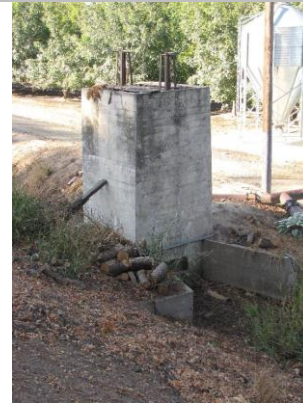
UCIP Comments: No access to inspect slide gate on LS. Roof of pumping house deteriorating and debris scattered on landward side. WS crossing not found. This crossing was listed in the USACE Periodic Inspection as ID# USACE_CESPK_MA1C_2010_p_345 no issues recorded 7/18/2013 Same as last inspection 12/17/2013 Same as last inspection.

Pump house located on landward slope.

Standpipe located at the landward toe.

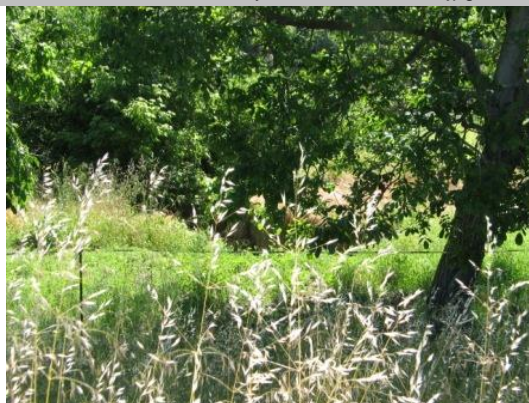
Photo 1 of 1 : rduffey_s_20140304_323.jpg

View of the erosion along the waterside of the levee.

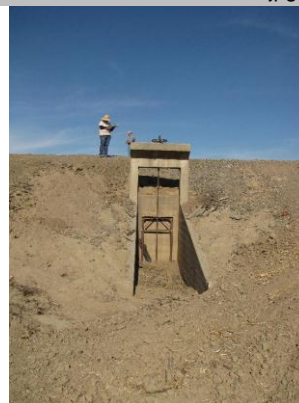
Photo 1 of 1 : UCIP_5017.jpg

WS concrete structure with slide gate. Gate is blocked by sediment.

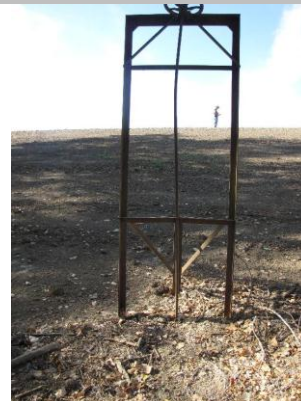
Photo 1 of 1 : UCIP_5024.jpg

Slide gate buried-non-functional.

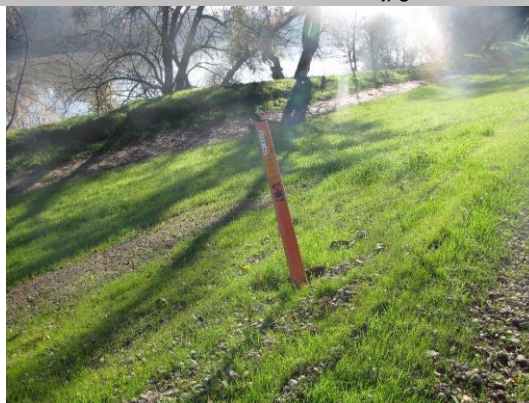
Photo 1 of 1 : UCIP_5034.jpg

Damage marker located on waterward slope.
